Part 6: Fire-Induced Changes in Aquatic Ecosystems

Jeffrey L. Kershner, Lee MacDonald, Lynn M. Decker, David Winters, and Zamir Libohova

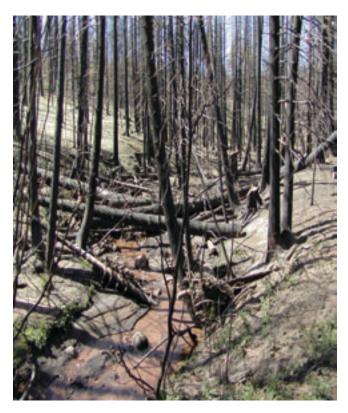
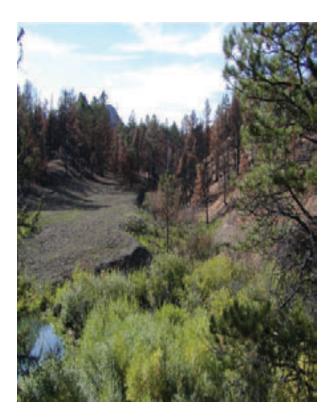
Figure 20—Riparian areas along streams within the fire area were differentially affected by the fire. Note presence of ash and fine sediment in picture on the left and minimal effects to riparian community on the right.

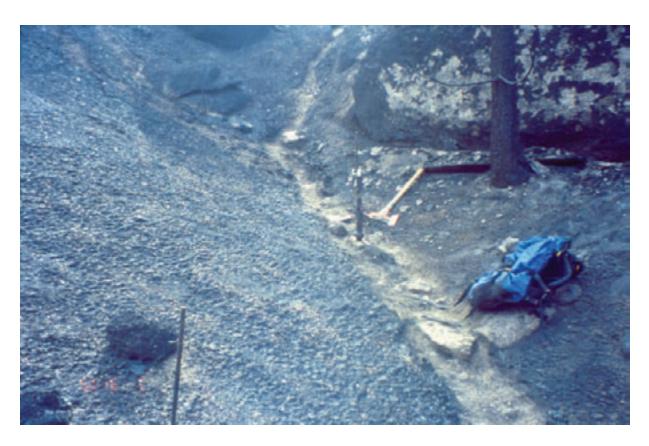
Figure 21 - Rills and incised channels in a study swale in Upper Saloon Gulch after the fire.

severely burned. By mid-July we had reestablished the sediment fences that had been burned by the Hayman Fire. On 21 July 2002 a rainstorm of only 19 mm resulted in an average sediment yield from the 20 swales of $0.6~{\rm kgm^{-2}}$. Each of the swales had developed an extensive rill network and a clearly incised channel as a result of this event (fig. 21). Permanent cross-sections established in six swales indicated that the newly formed channels were up to 45 cm wide and 15 cm deep.

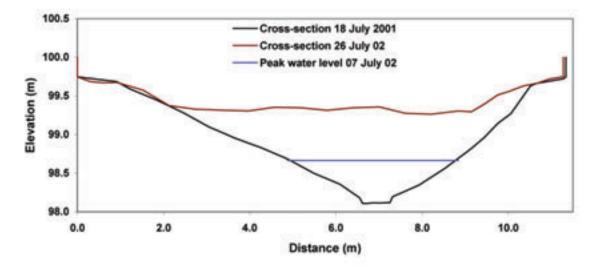
Figure 22—Cross–section of the channel in Saloon Gulch immediately upstream from the flume prior to the fire in summer 2001 and in July 2002 after the fire and a 19-mm storm event.

At the watershed scale, the effects of a 19-mm storm on July 7 were remarkable. The flume in Upper Saloon Gulch, together with its 3-m approach section, was completely buried by the sediment eroded off of the hillsides and out of the headwater channels. A comparison of the prefire and postfire cross-sections shows that over 1 m of sediment was deposited (fig. 22). At the mouth of the Saloon Gulch watershed, a large alluvial fan has been deposited. This fan extends into the channel of the South Platte River, and the erosion of the distal edge of this fan is introducing substantial amounts of fine sediment into the South Platte River.

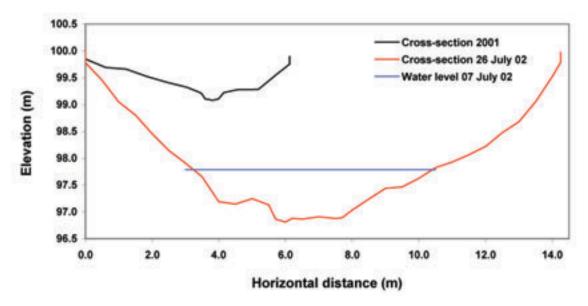
Figure 23—Channel cross-section in Brush Creek immediately upstream of the flume prior to the fire in summer 2001 and in July 2002 after the fire and a 14-mm storm event. The two cross-sections are each plotted relative to different benchmarks as the rebar established in 2001 were lost.

At Brush Creek the rebars marking the channel cross-section were destroyed by the July 7 storm, but figure 23 shows the relative change in channel dimen-

sions. The high water mark at Brush Creek was clearly distinguishable by the deposition of ash, and this indicated that the peak flow depth was close to 2 m. The flume itself was filled with fine sediment, woody debris, and boulders up to 50 cm in diameter. The particle-size distribution after this event showed a much greater preponderance of fine sediment, as the percent of the channel bed smaller than 8 mm in diameter increased from 35 to 70 percent (fig. 24a,b). The observed changes in the bed material at Brush Creek can be expected to sharply reduce macroinvertebrate density and diversity in the short term.

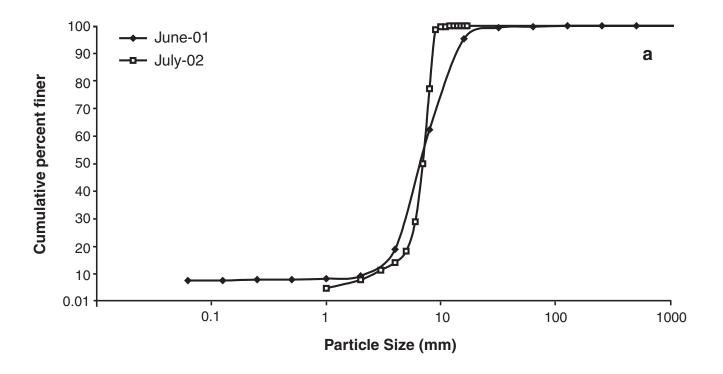
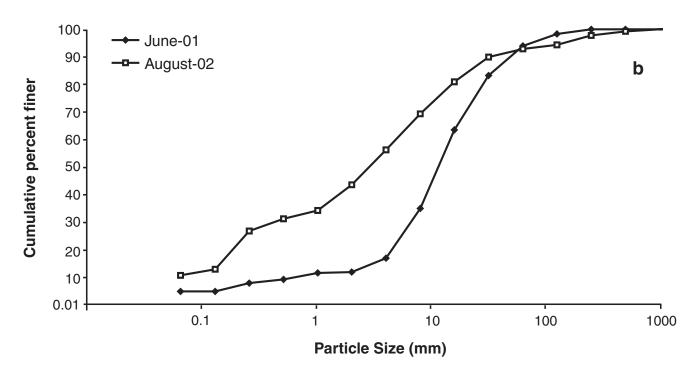
Figure 24—Size distribution of the bed material before and after the Hayman Fire in (a) Saloon Gulch and (b) Brush Creek.

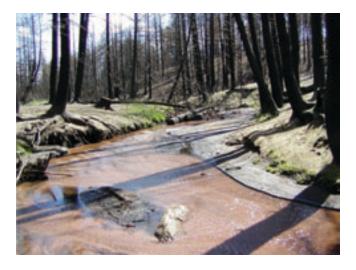
Figure 25—Sedimentation of stream bed as a result of surface ravel and coarse-grained sediment inputs from ephemeral tributaries. Woody debris has trapped sediment in the area directly upstream.

Immediate postfire response of the invertebrate community was also affected by the amount of sediment and debris transported into small streams from surface ravel and during initial runoff events. Stream channel sedimentation was occurring in many of the streams that we visited (fig. 25). Previous studies documented a decline in both diversity and biomass in some streams affected by fires where channel sedimentation has occurred (Minshall and others 1995, 2001; Rinne 1996). Local effects related to sedimentation appeared to be highly variable. Where large woody debris was present in sufficient quantity or there were beaver dams present to trap sediment, it appeared that stream substrate immediately downstream was much more heterogeneous.

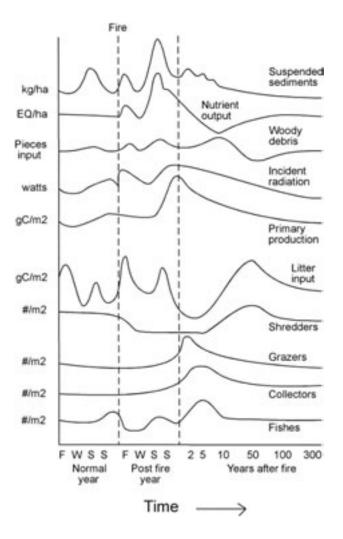
Figure 26—A generalized temporal sequence of selected events in response of aquatic ecosystems to fire (from Minshall and others 1989; Gresswell 1999). Note the short-term inputs of sediment and nutrients that may occur in the first few years after a fire. Most other major fire-related disturbances to streams, such as debris flows or flooding, typically occur within the first few years after a fire.
